# Manhole Inspection Summary

Manhole # S21YY1012MH

Insp Date: **11/28/06 8:53 AM**

**Location** Address: **106 CROSS KEYS RD**

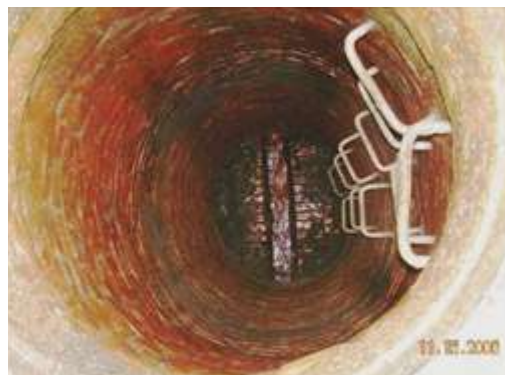
Top View

Evidence of surcharge - Bench debris.

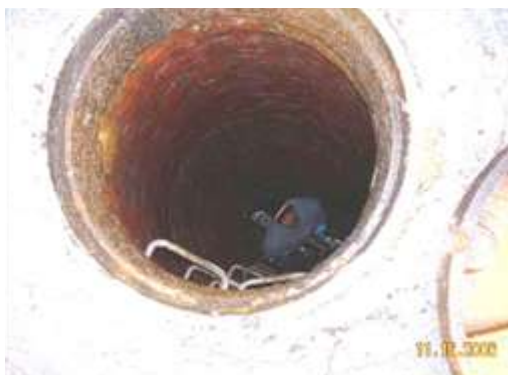
Defect

Frame leaks. Adjustment infiltration - other side.

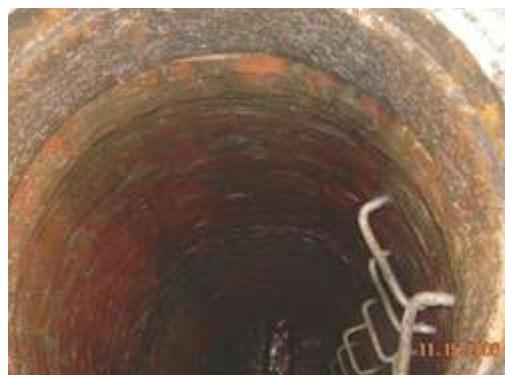
Defect

Frame leaks. Adjustment infiltration.
